Percutaneous solutions for biliary stent dysfunction: pictorial essay

Nunes TF, Tibana TK, Andrade GHV, Levigard RB, Nogueira FD, Szejnfeld D. Percutaneous solutions for biliary stent dysfunction: pictorial essay. *Radiol Bras.* 2021 Jan/Fev;54(1):43-48.

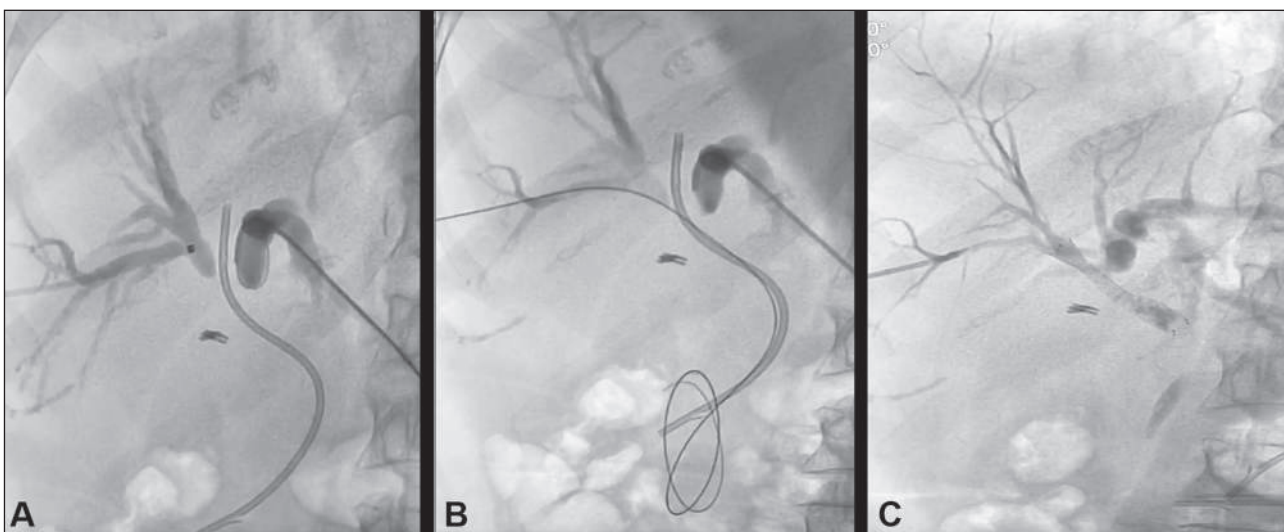
Figure 1. A 60-year-old female patient with Bismuth type IV cholangiocarcinoma underwent an endoscopic procedure for the implant of a 7 Fr plastic biliary stent. At 10 weeks after the procedure, her jaundice worsened. Computed tomography of the abdomen showed marked dilatation of the intrahepatic biliary tract due to improper positioning of the biliary stent. Percutaneous drainage and bilateral cholangiography (A) showed the failing plastic biliary stent. The stent was dislodged with a diagnostic catheter (B) and a new 6 × 60 mm biliary stent was placed in the right pre-papillary biliary tract (C). It was not possible to resolve the stenosis in the left biliary tract, and unilateral drainage was therefore performed. Her bilirubin levels normalized by day 30.

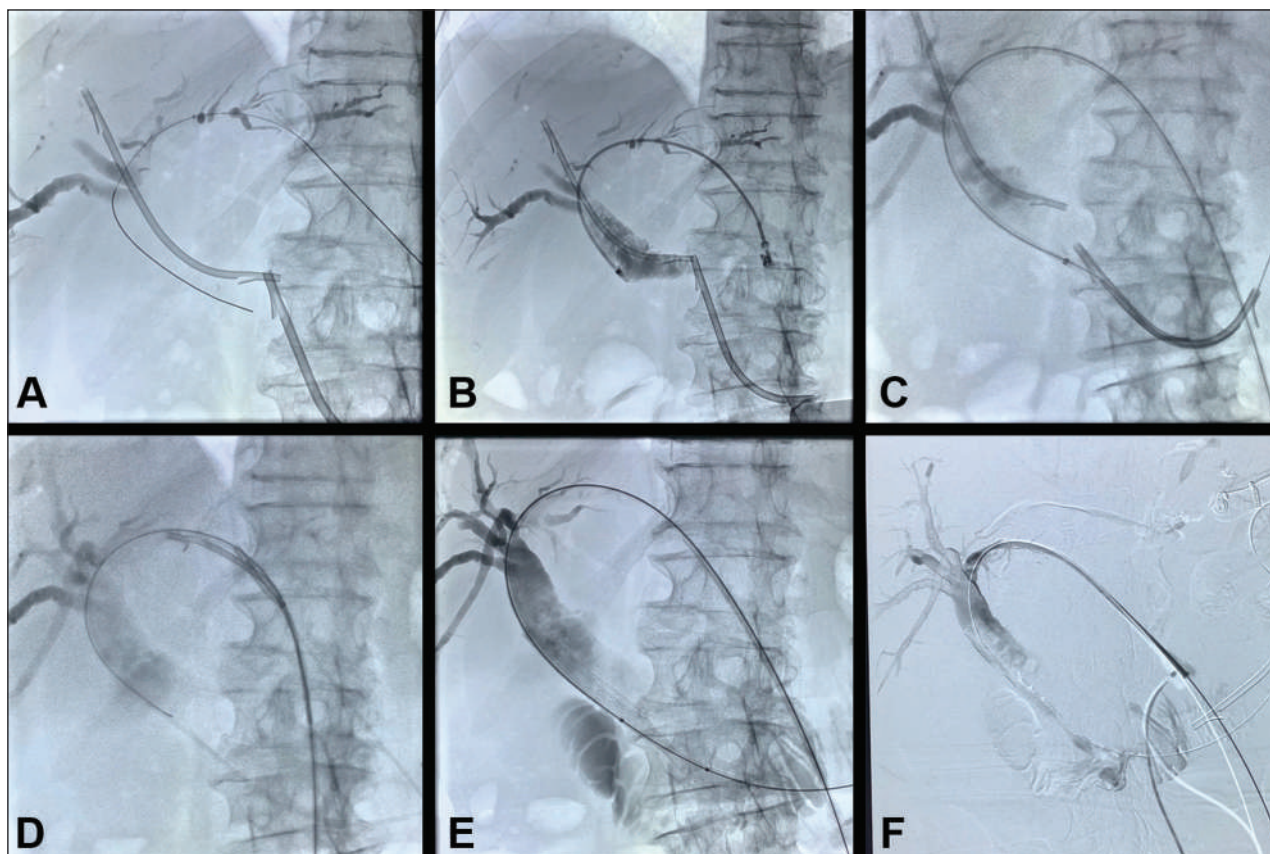
Figure 2. Patient with pancreatic neoplasia in whom a plastic biliary stent was placed via ERCP and developed an occlusion. A new attempt was made by first moving the old stent upward and then inserting a new one adjacently (A), although it did not result in an improvement in the jaundice or cholangitis. A percutaneous approach was used in order to position the new (distal) plastic biliary stent within the duodenum (B,C) and the old (proximal) stent was removed with a snare (D). A metal biliary stent was then put in place (E,F), resulting in improvement of the clinical and biochemical parameters.

When using a snare (Figure 2), the free peripheral end of the fragment of the fractured catheter is captured with the loop and firmly gripped, the fragment then being removed by using continuous traction^(1,2). When a balloon catheter is used, a guidewire is introduced into the percutaneous transhepatic tract and positioned within the fragment. The balloon can then be partially or completely inflated and pulled through the tract. However, this technique is highly operator dependent and takes more time, thus increasing the level of radiation to which the patient and the operator are exposed⁽⁶⁾.

Various techniques have been described for moving a failing plastic biliary stent into the intestine (Figure 2).

Percutaneous transhepatic removal of a plastic biliary stent can be performed by using a snare⁽¹¹⁾ or by the modified technique described by Gümüş⁽⁷⁾, as illustrated in Figure 2. The Gümüş technique can be performed within the biliary tree or in the duodenum after the repositioning of the stent through the use of a long introducer sheath or a guide catheter⁽⁷⁾. Some authors have concluded that it is safer to perform these maneuvers in the duodenum (after the repositioning) than in the biliary tree^(7,13).

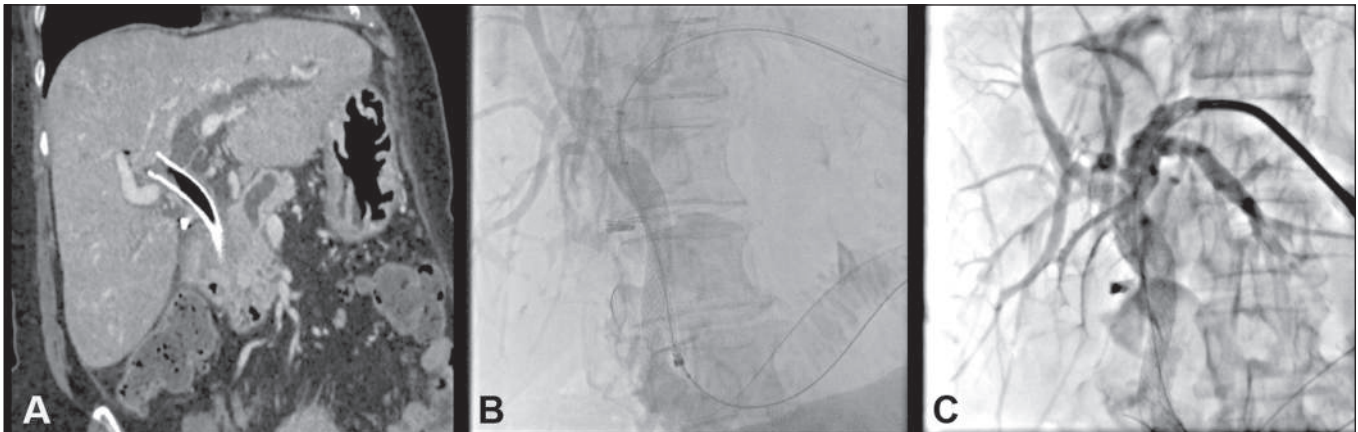
Figure 3. An 80-year-old female patient, with locally advanced adenocarcinoma of the pancreatic head, who presented with cholangitis. She underwent an endoscopic procedure to implant a metal stent (WallFlex; Boston Scientific, Marlborough, MA, USA). At two weeks after the procedure, her jaundice worsened. Computed tomography of the abdomen revealed marked dilatation of the left intrahepatic biliary tract—the consequence of an improperly positioned biliary stent, selective in the right hepatic duct by upward migration, occluding the confluence with the left hepatic duct (A). Another endoscopic procedure was performed to remove or reposition the stent. After its distal end had been captured, it was possible to crack the ring and the coating of the stent without moving it. Cholangiography showed peri-stent contrast retention and positioning of a different metal stent (Viabil; W.L. Gore, Flagstaff, AZ, USA) parallel to the WallFlex stent (B). Postprocedure cholangiography showed satisfactory biliary drainage into the duodenum (C).

Parallel metal biliary stent placement (Figure 3) in cases of previous occlusion can be performed with “side-by-side” or “stent-in-stent” insertion; the latter configuration is complex, the placement of more than two stents is rarely reported, and retreatment is challenging or impossible⁽¹⁵⁾. “Side-by-side” stent placement is the preferred configuration, because it allows reocclusion to be corrected more easily, especially in cases of transpapillary stent placement⁽¹⁶⁾.

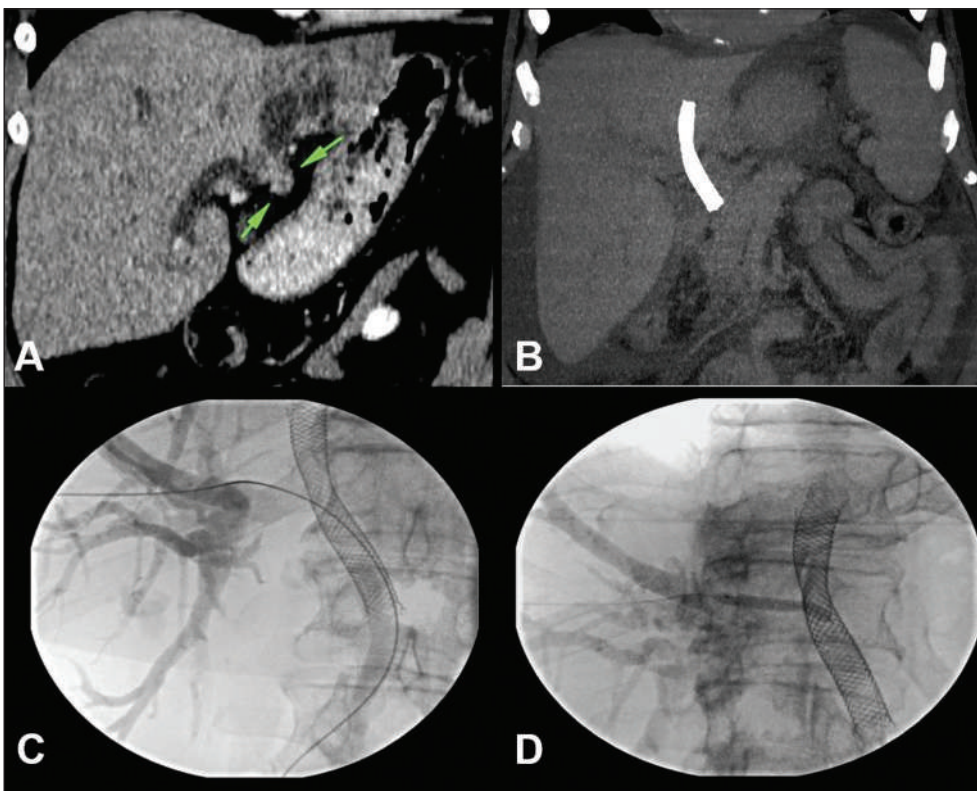
Figure 4. A 71-year-old male patient presenting with obstructive jaundice due to neoplasia (A). A coated, covered metal biliary stent was placed via ERCP. However, the stent placement did not result in an improvement in the obstruction. Subsequently, ERCP was again performed in order to place another (fenestrated) stent within the previously positioned stent. Computed tomography showed the original stent positioned in the left biliary tract (atrophied hepatic segment) and increased biliary dilatation in the right hepatic lobe (B). Because of the cholangitis, external percutaneous drainage of the right biliary tract was performed as an emergency procedure. After 60 days, the patient underwent the removal of the external drain and the RUPS-100 kit was used in order to introduce a hydrophilic wire into the original stent (C). Direct percutaneous puncture of the coated biliary stent was performed with the RUPS-100 cutting needle, after which a 5 × 40 mm expanding coronary balloon stent was positioned (D). The procedure resulting in technical success with no complications.

cases, an option would be to perform a “stent-in-stent” insertion with a transjugular liver access kit (RUPS-100; Cook Medical Inc., Bloomington, IN, USA) to perforate the covered biliary stent mesh (Figure 4).

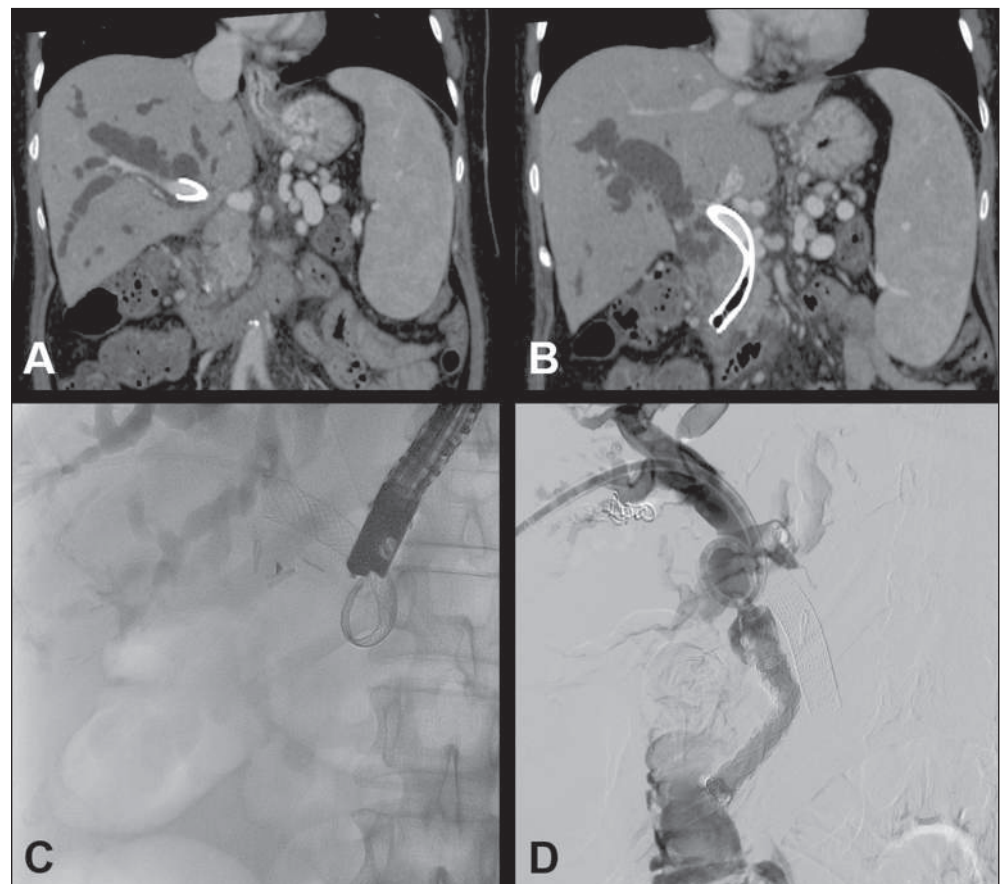
Figure 5. Female patient with locally advanced, inoperable pancreatic cancer. She underwent ERCP for the placement of a metal biliary stent, thereafter evolving to controlled hemorrhagic shock, followed by sepsis. Contrast-enhanced computed tomography of the abdomen and pelvis showed the proximal portion of the stent in the portal vein and its distal portion in the duodenum (A,B). We simultaneously performed procedures for percutaneous drainage of biliary ducts, removal of the porto-duodenal stent by ERCP, and percutaneous portal angioplasty for occlusion of the porto-duodenal fistula (C,D).

It is important to position the stent appropriately within in the portal vein, avoiding occlusion of intrahepatic portal branches (Figure 5). After the porto-duodenal fistula has been closed, the new biliary stent can be put in place.
